(Final Report, Revised August 26, 2013)
Condition Assessment
and
Reserve Fund Plan
2014
for
Bethesda
Place
Bethesda, Maryland

RE: **CONDITION ASSESSMENT AND RESERVE FUND PLAN 2014**
Bethesda Place Community Council, Inc.
(Final Report, Revised August 26, 2013)
Bethesda, Maryland
Project No. 7535

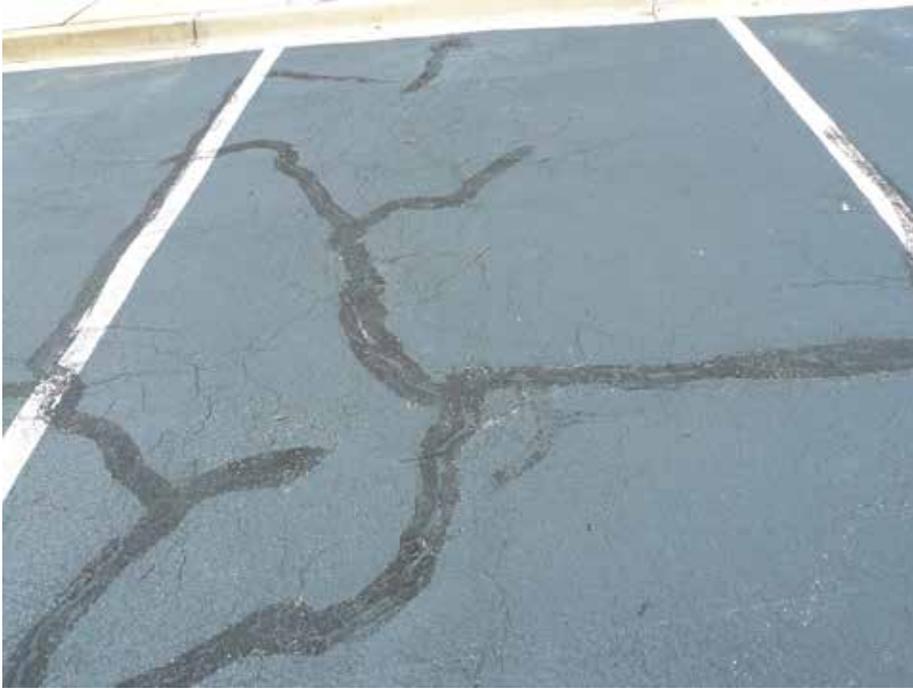
PHOTO #1
The parking bays of the Surreywood Lane side of the community range from poor to fair condition. A large amount of deflected pavement was observed.

1.1	Asphalt Restoration Project - Phase 1	3,227	SY	\$15.00	\$48,405	18	2016	100%	\$51,353	2034	100%	\$87,425				Phase 1 includes the Derbyshire Lane, Surreywood Lane, and the 7200 block of Greentree Road asphalt parking bays and one driveline. Neither the depth nor the sub-base of the pavement could be visually determined. We understand that the pavement is original, and it is in poor condition. Heavy areas of alligator cracking (indicative of sub-base damage or insufficient asphalt depth) were observed on the drivelines and parking bays. Restoration includes milling to a possible depth of 2 1/2" and asphalt replacement. Core sampling should be used to determine the depth and condition of the sub-base and pavement prior to restoration. Costs include striping, but not replacement of any inadequate sub-base.

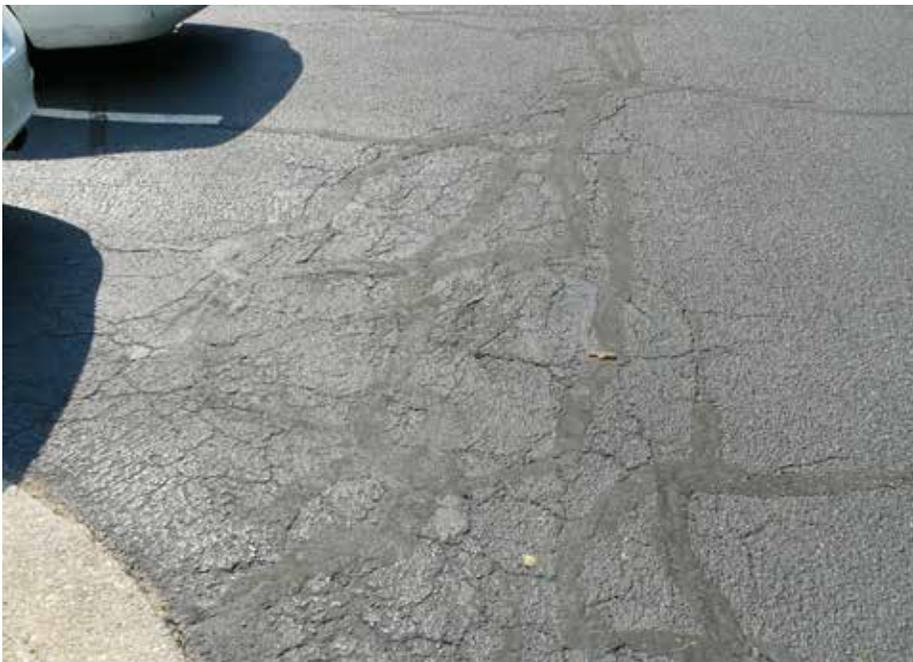
PHOTO #2
The front driveline and parking bays of Green Tree Road are also in poor to fair condition. The Phase 1 streets and parking bays have been scheduled for near-term full width mill and asphalt replacement.

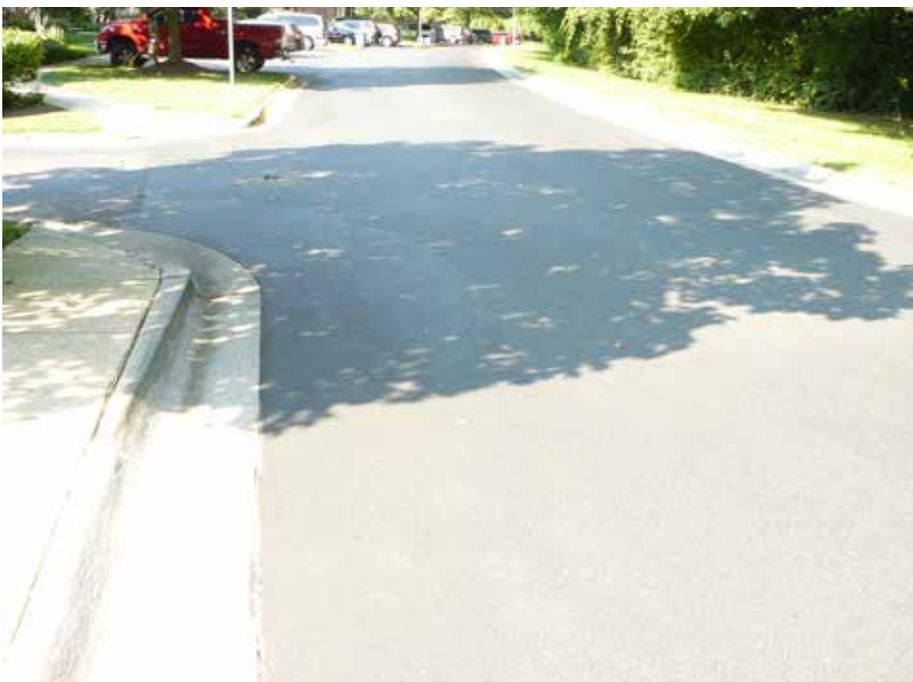
PHOTO #3
The drivelines and parking bays at the end of Green Tree Road received restoration circa 2003 and are in overall good condition. All asphalt drivelines and parking bays throughout the community received recent crack filling and seal coating.

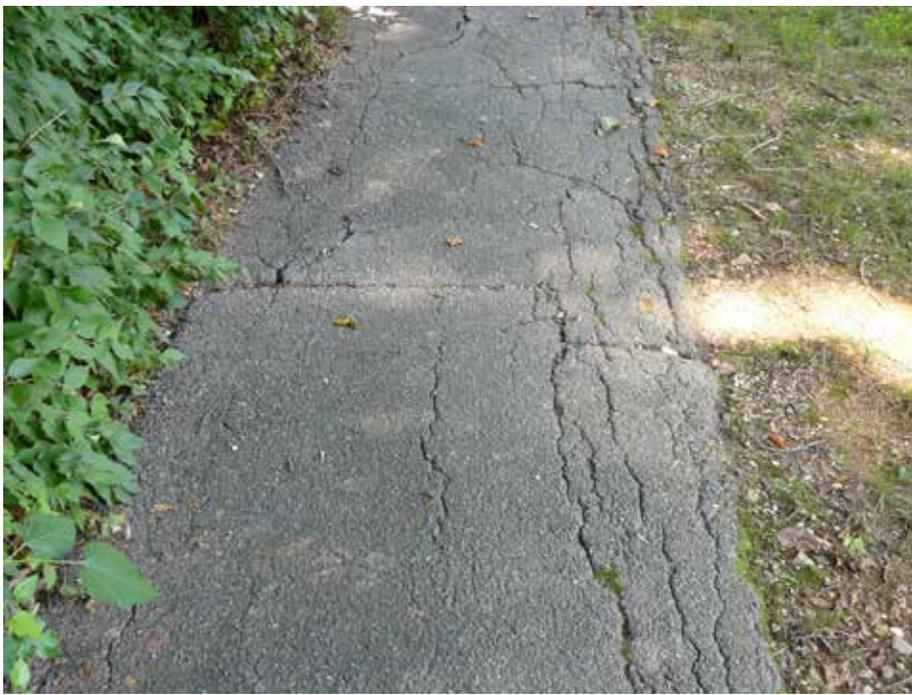
1.5	Asphalt Footpath	140	SY	\$36.00	\$5,040	15	2014	50%	\$2,520	2024	50%	\$3,387	2034	50%	\$4,551	An asphalt footpath generally 4' in width is constructed behind the townhomes on Surrywood Lane. The footpath is in generally poor condition. We observed significant transverse cracking and tripping hazards. We have scheduled its restoration near-term.
2 CONCRETE COMPONENTS

PHOTO #4
The asphalt footpath is in fair condition. A significant amount of longitudinal and transverse cracking was observed.

6.6 Asphalt Footpaths: Transverse and longitudinal cracks should be cleaned of debris and plant growth (lanced) and filled with a rubberized asphaltic compound to prevent water infiltration. Cracks and deflection of the asphalt pavement can develop in the areas where tree roots cross the path. Tree roots should be removed and damaged areas repaired. An additional maintenance issue with footpaths is vegetation control. In areas where vegetation encroaches on the paths, both underfoot and overhead, visibility is reduced and personal injury can occur from low-growing branches. Vegetation control should be accomplished on a regular basis under the maintenance budget for safety considerations and to extend the useful service life of the pavement.

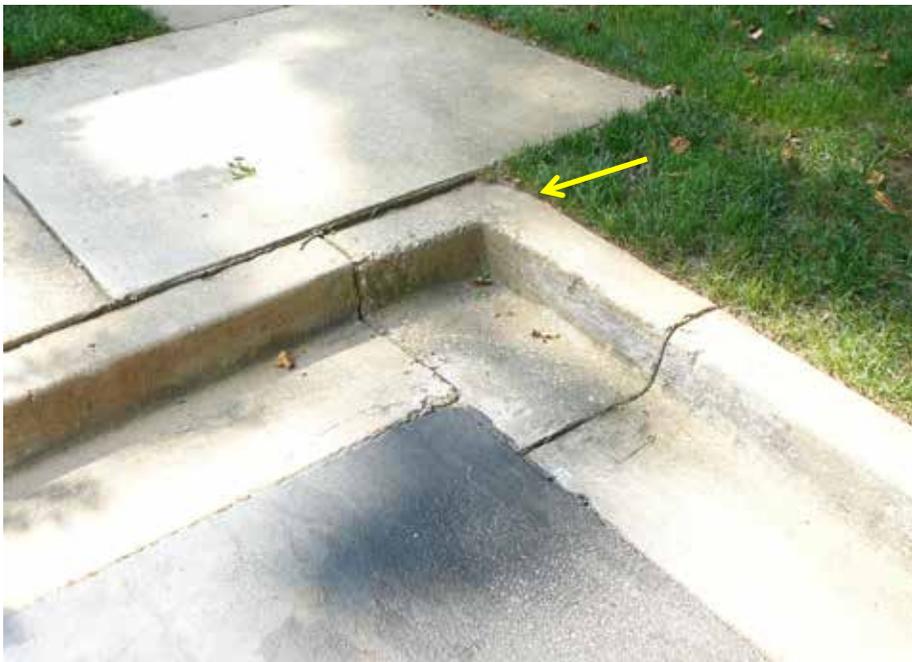
2.2	Concrete Curbs & Gutters	2,648	LF	\$36.00	\$95,328	5	2014	2%	\$1,907	2018	2%	\$2,146	2023	2%	\$2,488	The drivelines and parking bays are lined with standard-profile, cast-in-place, concrete curbs and gutters. They are in generally good condition with about 1.8% of the length exhibiting transverse cracks or settled sections. We observed approximately nine damaged sections, which should be replaced. Minor chips usually do not justify replacement. Curb paint is in fair condition and curbs can be repainted under the operations budget. Cyclic repairs are scheduled, as full replacement at one time is not appropriate or anticipated. Curb repairs are scheduled to coincide with work on other concrete components to maximize economies of scale. The Board should be aware that repairs to small quantities of concrete may be more costly because of the difficulty of attracting competitive bids for small projects, which may not meet contractor minimums. Any trip hazards or surface deficiencies should be addressed as soon as practicable to prevent personal injury.

PHOTO #5
This corner section of curb and gutter has settled. This settlement creates a potential tripping hazard at the sidewalk, which should be repaired.

6.8 Concrete Curbs and Gutters: Vehicle impacts, differential settlement, construction damage, and cracking and spalling of the concrete will eventually result in the need for replacement of some curb sections. A typical damaged or settled section, usually 10 feet in length, will be removed by saw cutting or jack hammer and re-cast. Replacements are scheduled in cycles because the necessity of full replacement at one time is unlikely.

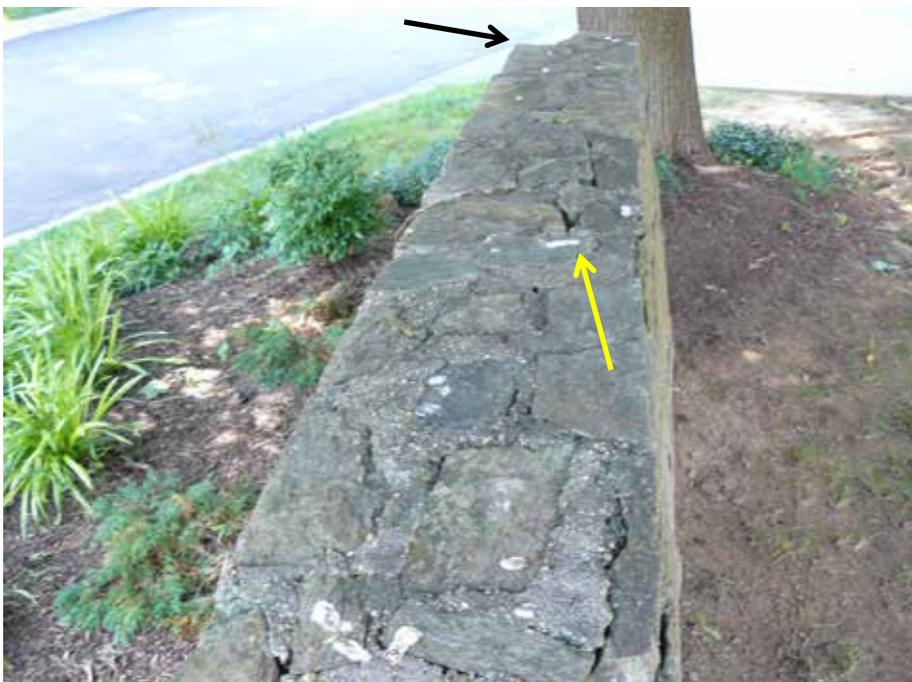
3 SITE FEATURES																
3.1	Stone Entrance Features Allowance	1	LS	\$19,000.00	\$19,000	40	2021	100%	\$23,368	2057	100%	\$67,726				Two stone and mortar monuments are constructed at each entrance to the community. Each monument is about 9' x 3' x 2' wide with a wood community name sign attached. All stone and mortar appear to be in poor to fair condition with some deteriorated mortar, cracked or missing mortar, and missing stones. The monuments are nearing forty years of age and require restoration in a few years. With periodic maintenance performed under the maintenance budget, when the monuments receive restoration, they should have a very long service life.

PHOTO #6
Both entrance monuments are missing stones and require tuckpointing, as the mortar on top of the walls has deteriorated allowing water to infiltrate through the walls. This should be repaired under Operations.

6.9 Stone Monument Repair: Stone monuments should be inspected periodically for cracks indicating settlement problems. All vegetation, such as vines, tree limbs, and tree roots should be kept clear to prevent damage. As stone monument walls age, depending upon the initial quality of the mortar and the long-term environment of the wall, mortar joints may deteriorate. This condition can be corrected by tuckpointing. Deteriorated or cracked mortar should be removed, and the void should then be filled with new mortar. Major settlement cracks or deflection may require the rebuilding of that section.

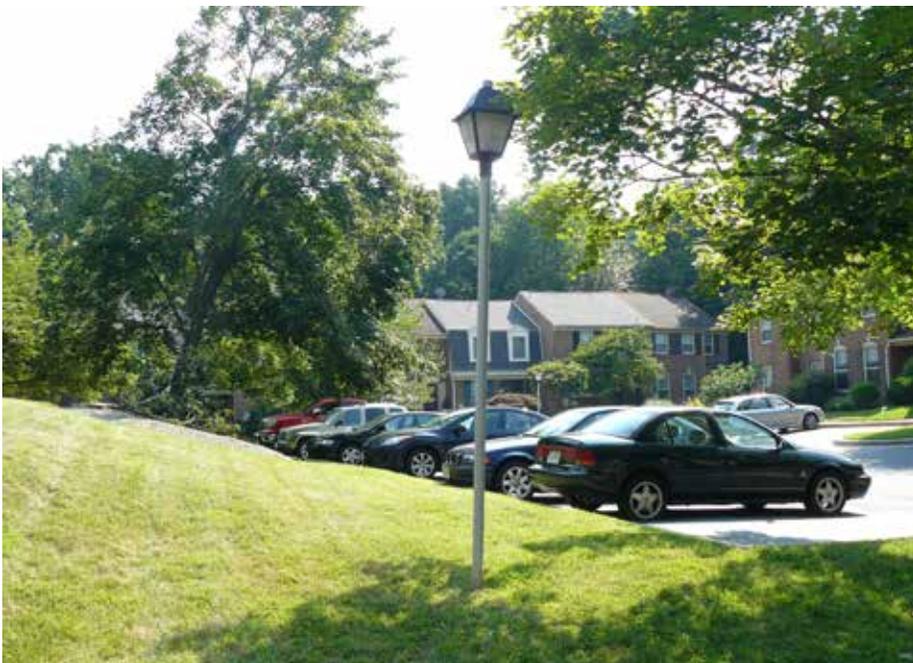
3.4	Light Poles & Fixtures	12	EA	\$2,600.00	\$31,200	35	2025	100%	\$43,188	2060	100%	\$121,525				Management advised that the community is responsible for maintenance and replacement of the street lights. Approximately 12 metal light poles, about 12' high, with traditional lantern fixtures provide street and area illumination. They appear to range from fair to good condition. The lighting was not observed after dark. No problems were reported with lighting. We understand that two new lights were recently installed.

PHOTO #7
The street lights range from fair to newer condition, as some lights have been recently installed on the Green Tree Road section of the community.

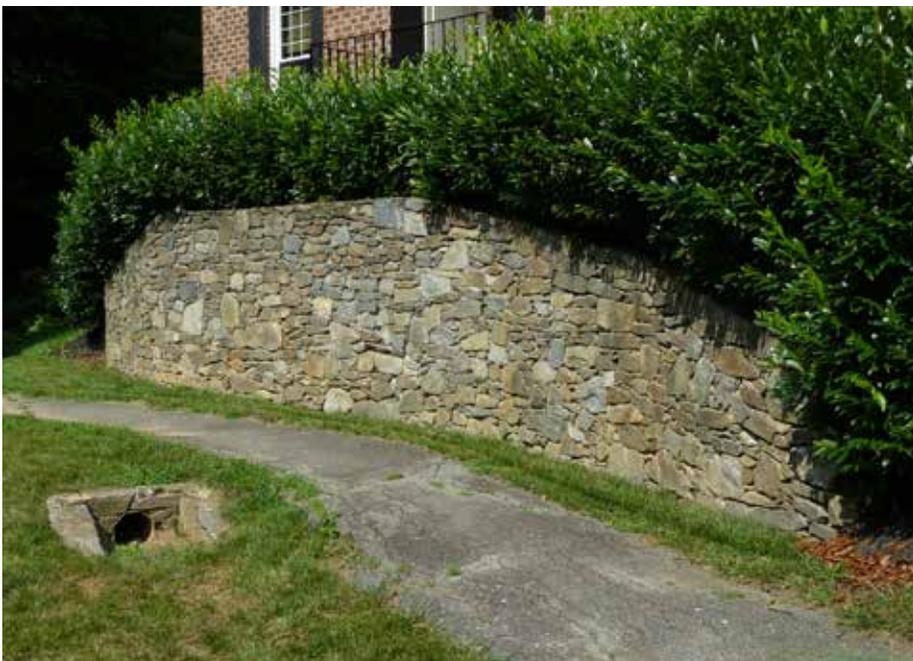
3.5	Stone Retaining Wall	228	SF	\$60.00	\$13,680	50	2038	100%	\$27,809							A 38' x 6' stone retaining wall is constructed below the townhome on 6791 Surreywood Lane. The wall appears to be in good condition, with no deflection or missing mortar observed. These observations should be viewed in the context of capital reserve budget projections, and not as a structural analysis. Any questions regarding the safety or structural integrity of the walls should be referred to a professional engineer.

PHOTO #8
The stone retaining wall constructed near 6791 Surrywood Lane is in good condition. No major deficiencies were observed.

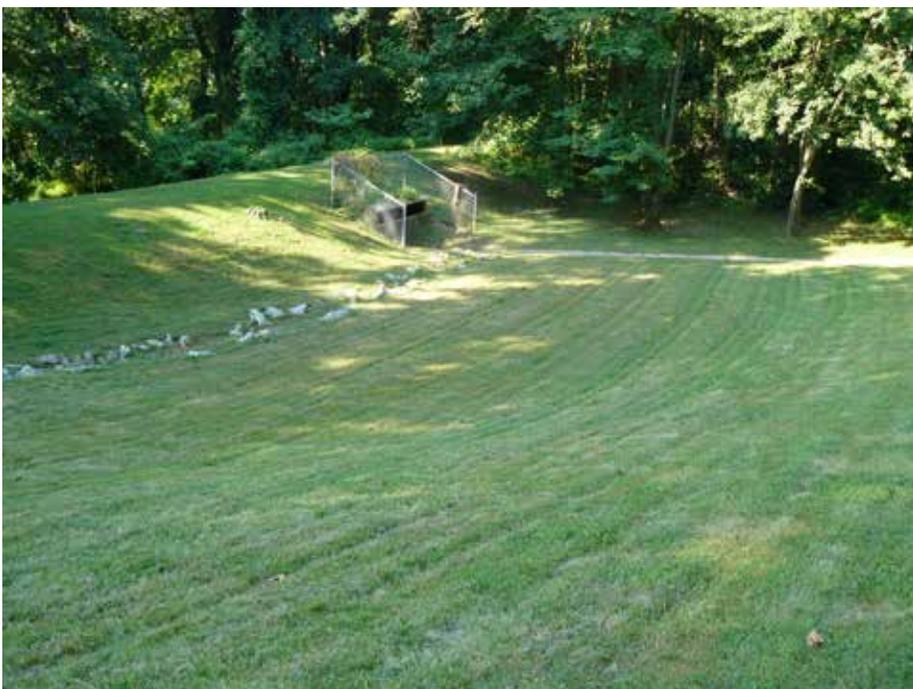
PHOTO #9
Both of the storm water detention ponds have been mowed and most vegetation has been removed. This maintenance practice should continue.
